# Arborist Report

**Prepared for: Dave Atwal**

**Proposed site: 24830 Fairview Ave Hayward, CA**

**Prepared by: Ronald Carden, Certified Arborist WE-3445A**

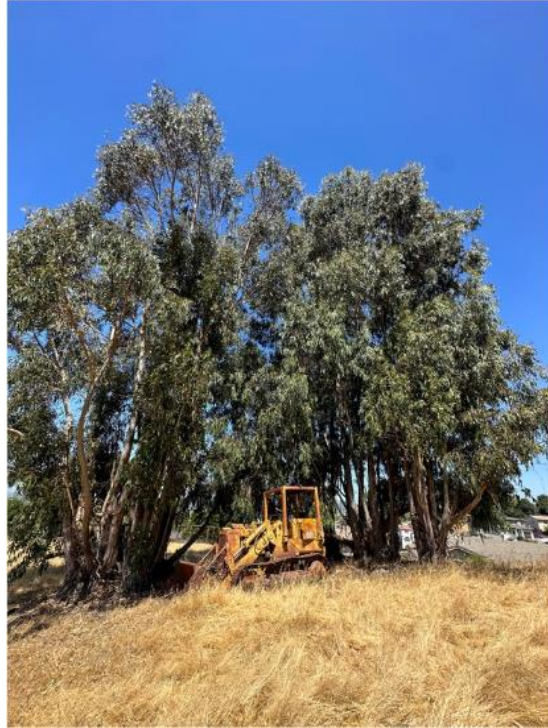
**Trees 1-4**

Tree #	Species	DBHs	Rating	Maintenance	Remarks
1	Bluegum Eucalyptus 'Eucalyptus globulus'	9,8,8,5,4,4,4,4	45%	Little to none	Sprouted from a stump, multitrunk
2	Bluegum Eucalyptus 'Eucalyptus globulus'	11,11,10,9,9,6,6,5,5,5,4	45%	Little to none	Sprouted from a stump, multitrunk
3	Bluegum Eucalyptus 'Eucalyptus globulus'	11,11,9,7,6,6,6,5,4	45%	Little to none	Sprouted from a stump, multitrunk
4	Bluegum Eucalyptus 'Eucalyptus globulus'	12,12,11,11,11,10,9,9,9,7,7,6,6,6,4	45%	Little to none	Sprouted from a stump, multitrunk
5	California Pepper 'Schinus molle'	18,8,7,6,6,5,3	60%	Little to none	Sprouted from a stump, multitrunk
6	California Pepper 'Schinus molle'	7,6,6,5,5,5,4,4	60%	Little to none	Sprouted from a stump, multitrunk
7	California Pepper 'Schinus molle'	6,5,4,4,3	60%	Little to none	Sprouted from a stump, multitrunk
8	California Pepper 'Schinus molle'	8,5,4,4,3	60%	Little to none	Sprouted from a stump, multitrunk

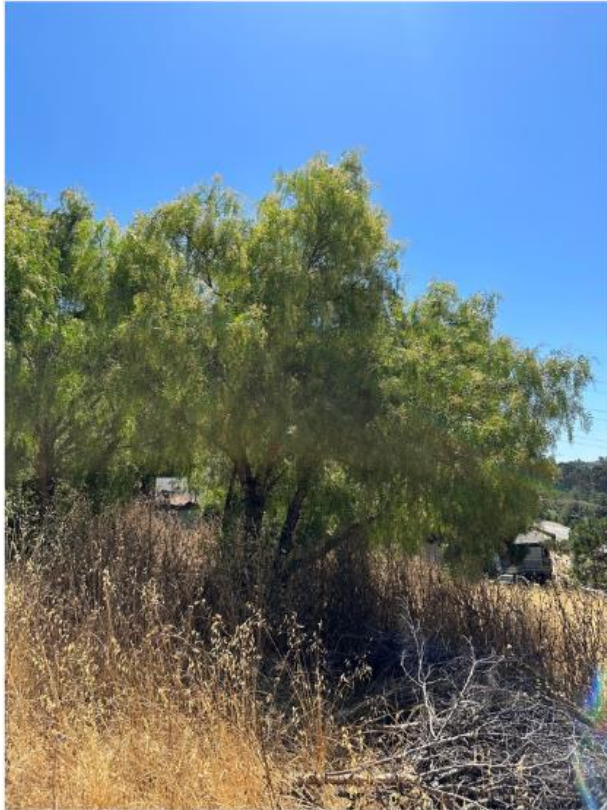
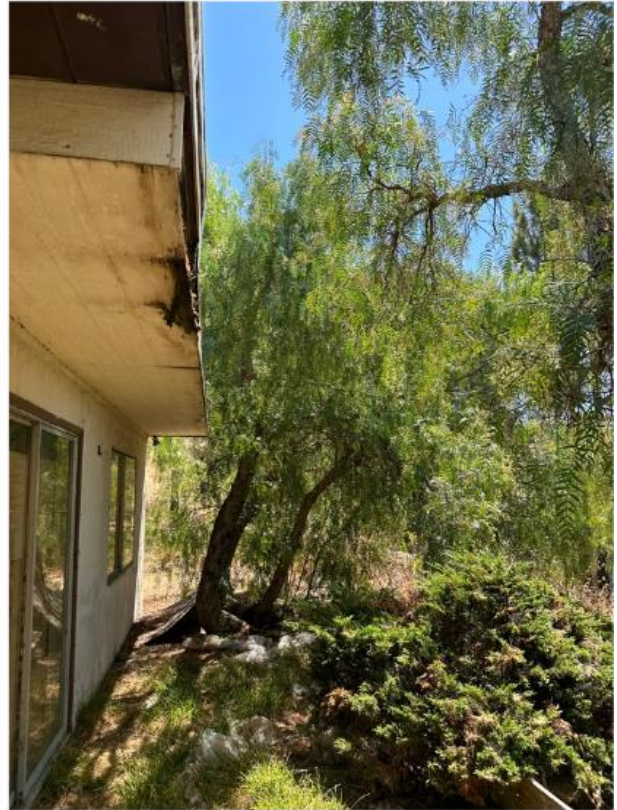
**Trees 7-8**

9	California Pepper 'Schinus molle'	8,5,4	60%	Little to none	Sprouted from a stump, multitrunk
10	California Pepper 'Schinus molle'	5,5,5,4,4,3,3,3	60%	Little to none	Sprouted from a stump, multitrunk
11	Coast Live Oak 'Quercus agrifolia'	10	75%	Little to none	Utility lines overhead, low crown, may need to be trimmed to get vehicles in
12	Velvet Ash 'Fraxinus velutina'	8,6,4	35%	Little to none	In state of decline, warped trunk
13	Coast Live Oak 'Quercus agrifolia'	8	75%	Little to none	Dense crown, vigorous
14	Italian Stone Pine 'Pinus pinea'	12,11	65%	Little to none	Vigorous
15	Italian Stone Pine 'Pinus pinea'	14	65%	Little to none	Vigorous
16	Coast Live Oak 'Quercus agrifolia'	7,5	75%	Little to none	Codominant trunks, dense crown
17	Coast Live Oak 'Quercus agrifolia'	14,13	60%	Little to none	Codominant trunks, dense crown
18	Bluegum Eucalyptus 'Eucalyptus globulus'	7	55%	Little to none	Vigorous
19	Bluegum Eucalyptus 'Eucalyptus globulus'	9,7	45%	Little to none	Codominant trunks

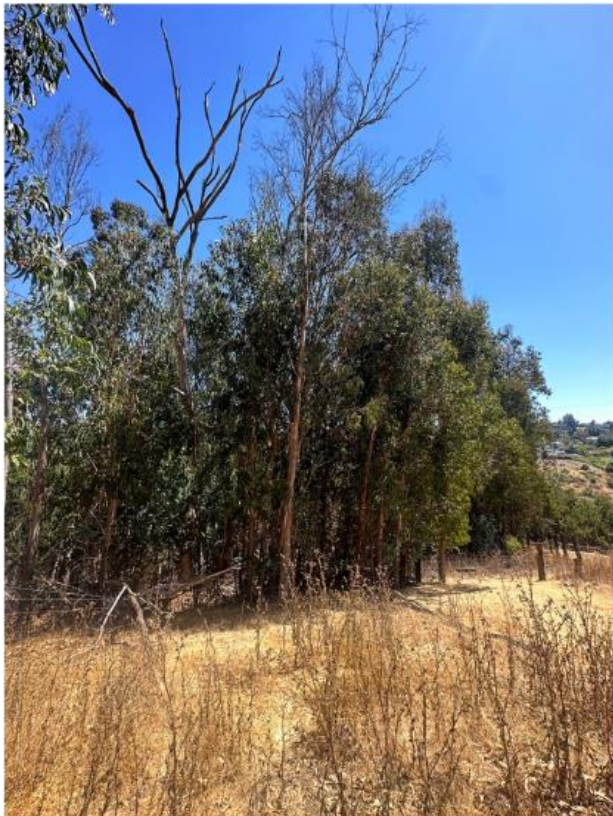
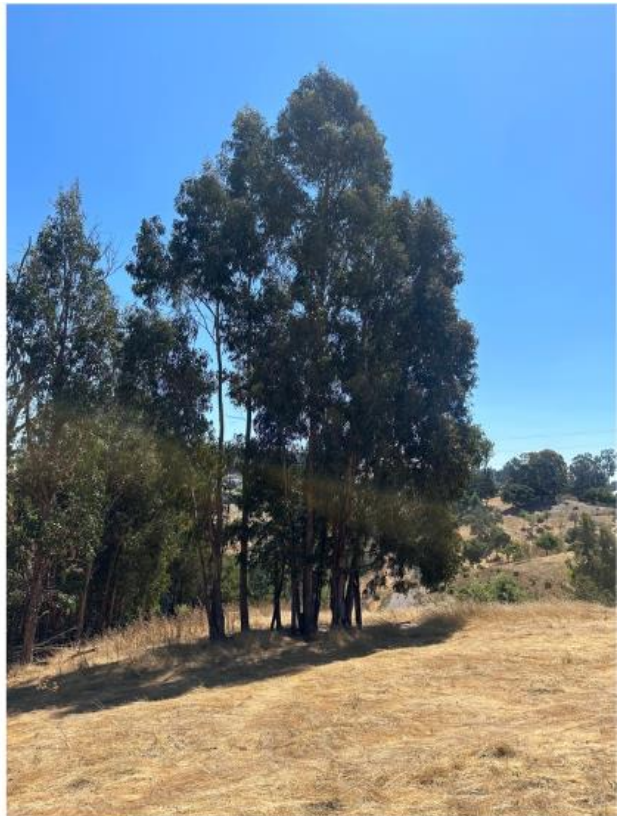
**Trees 18-29**

20	Bluegum Eucalyptus 'Eucalyptus globulus'	7,7,5,5	45%	Little to none	Multitrunk
21	Bluegum Eucalyptus 'Eucalyptus globulus'	12	55%	Little to none	Vigorous
22	Bluegum Eucalyptus 'Eucalyptus globulus'	7	55%	Little to none	Vigorous
23	Bluegum Eucalyptus 'Eucalyptus globulus'	8	55%	Little to none	Vigorous
24	Bluegum Eucalyptus 'Eucalyptus globulus'	8	45%	Little to none	Vigorous
25	Bluegum Eucalyptus 'Eucalyptus globulus'	6,5,5	45%	Little to none	Multitrunk
26	Bluegum Eucalyptus 'Eucalyptus globulus'	7	55%	Little to none	Vigorous
27	Bluegum Eucalyptus 'Eucalyptus globulus'	11,6	45%	Little to none	Multitrunk
28	Bluegum Eucalyptus 'Eucalyptus globulus'	10,5,4,4,4	45%	Little to none	Multitrunk
29	Bluegum Eucalyptus 'Eucalyptus globulus'	11,7,5	45%	Little to none	Multitrunk
